**Docket No. 217 – Development and Management Plan Inspection**

Northeast Utilities Service Company Certificate of Environmental Compatibility and Public Need for the construction of a 345-kV electric transmission line and reconstruction of an existing 115-kV electric transmission line between Connecticut Light and Power Company's Plumtree Substation in Bethel, through the towns of Redding, Weston, and Wilton, and to the Norwalk Substation in Norwalk, Connecticut.

**Date:** August 3, 2006

**Location:** 345kV Underground Route

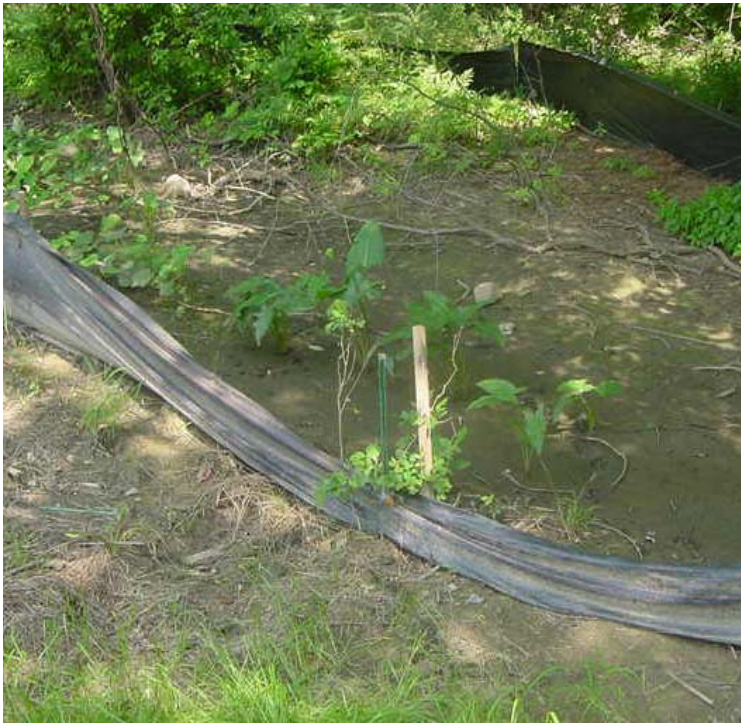
- Vegetative cover is not establishing as quickly in the mulched area to the east as the expectation was that wetland species would return naturally. 7/19-8/3/06	- Continue to monitor for vegetative cover. Repair and reinforce the controls to avoid the fence getting pushed down if not already done. 7/19-8/3/06	-Needs attention if not already done
	-Silt fence along the eastern wetland at the swale has also come down. 8/3/06	-This needs to be repaired/restapled. Reinforce fence along this wetland. 8/3/06	-Needs attention.

345kV (School Rd) Photo on the left shows the silt fence coming down along the eastern wetland swale. Controls should be repaired/restapled where necessary. Photo on the right shows a view of the restored area. Vegetation is returning slowly along this edge. 8/3/06

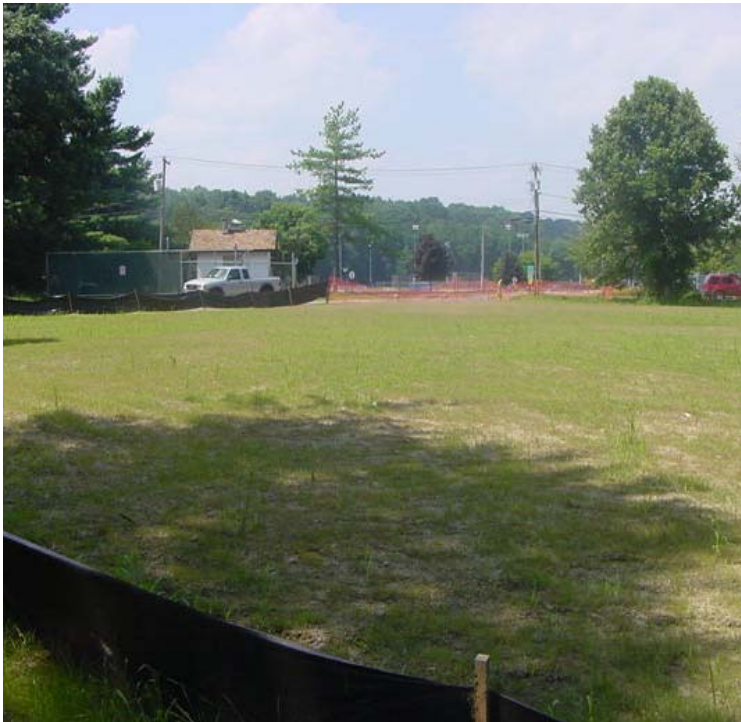
Photo on the left shows another view within the restored HDD site. Photo on the right shows the previously restored area heading north towards Allen's Meadow Park. Grass had stopped growing well due to the weather but is still stable at this time. 8/3/06

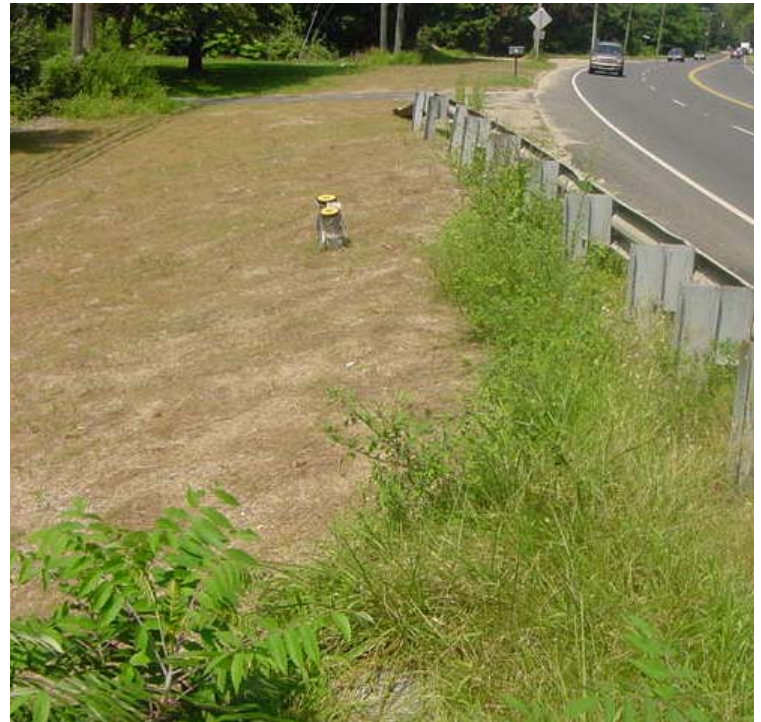
Areas of Inspection	Observation	Recommended Action	Corrective Action
Erosion and Sediment (E&S) Controls  <b>Route 7</b>	- Grass growth appears to have slowed at the high school J&B and north towards Allen's Meadow due to the weather 7/26-8/3/06	- Continue to monitor as grass is patchy but seems stable for the most part. 7/26-8/3/06	- N/A

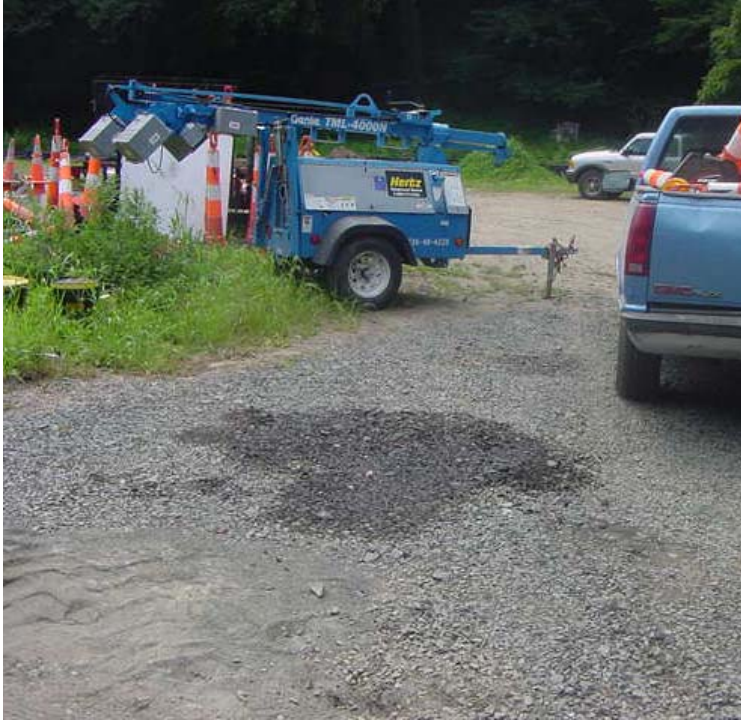
(Route 7) Photo on the left shows a potential spill in the gravel at the storage area near the Rt 107&7 intersection. Photo on the right shows the exit point of the Georgetown HDD near Church Street. Silt fence was down in this area and should be repaired. 8/3/06

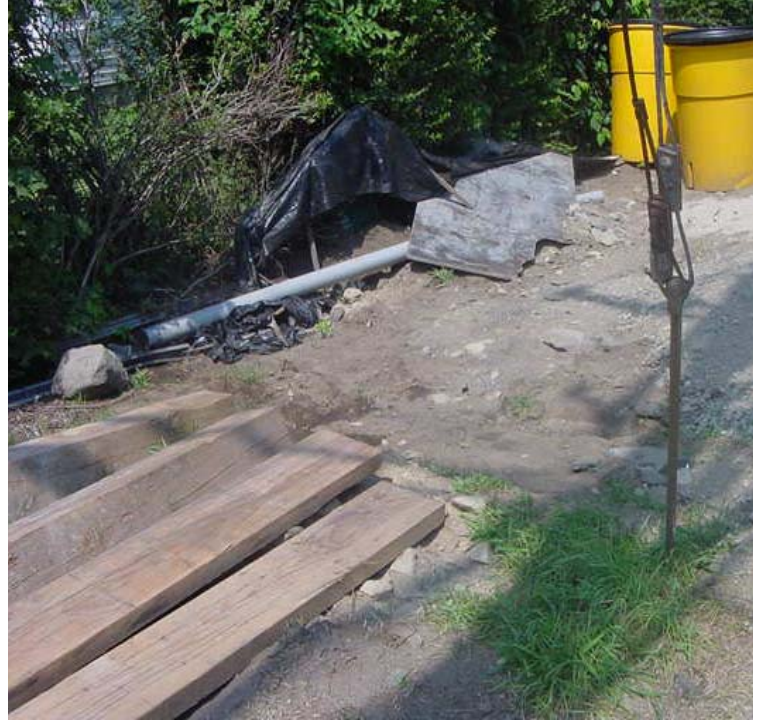
- The exit point for the HDD is located at Church St. Work is ongoing here. 7/5-8/3/06	- See erosion control section for recommendations. Silt fence needs repair 8/3/06	- See erosion control section

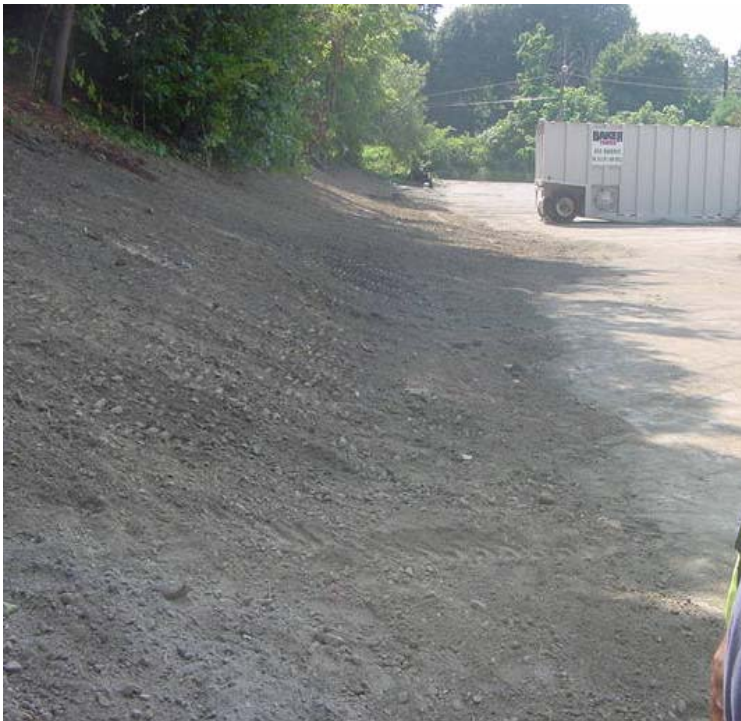
- Pipe installation was complete at the Georgetown HDD. The trench has been backfilled and equipment was demobilizing. 8/3/06	- See erosion control section for more information. 8/3/06	- N/A

(Georgetown HDD): Photo on the left shows a view of the backfilled trench with pipe installed and the HDD complete. A frac tank remains on site. Photo on the right shows another view of the completed HDD work site in the Gilbert & Bennett lot. 8/3/06
